## Diagnosis and Restoration of Four Historical Eiffel-Type Rail Viaducts

As part of the project management of the Auvergne rail restoration plan carried out by the Société d'études techniques et économiques (SETEC) on behalf of the French Rail Network (SNCFR, Société Nationale des Chemins de Fer Réseau), Diadès was responsible for the diagnosis evaluation of four wrought-iron nineteenth-century viaducts located on the Lavaufranche–Saint-Germain des Fossés line. Once the viaducts' archived documents had been analysed, a complete diagnostic and investigative programme was carried out, including taking dimensional measurements and samples, conducting detailed inspections, anti-corrosion diagnosis, spectrophotometry analysis of the gathered data and recalculation of the fatigue of the structures. These results were then used to create a procedure for the restoration and painting of two viaducts while addressing the problem of the presence of lead in the original paintwork.

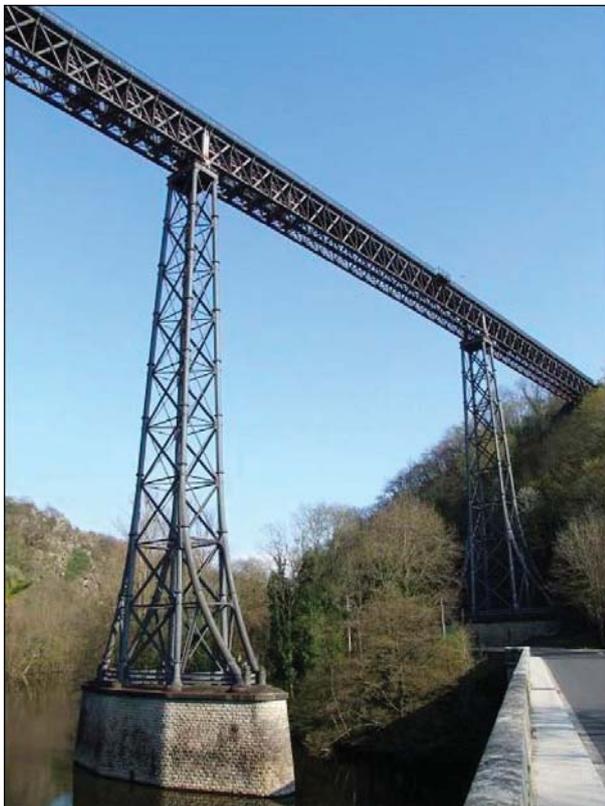
Figure 1. The Rouzat Viaduct

The Rouzat Viaduct is located in the municipality of Saint-Bonnet-de-Rochefort. It consists of three wrought-iron spans of 55.125, 57.75 and 49.125 m which are extended on the Commentry side by a stone access viaduct of approximately 13 m. The 162-m-long wrought-iron deck rests on two piers, each composed of four hollow cast-iron columns that are 500 mm in diameter.

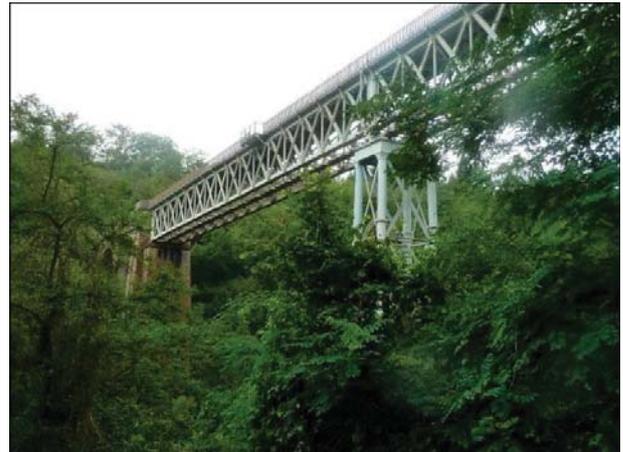
Figure 2. The Neuvial Viaduct

The Neuvial Viaduct is in the commune of Bègues. It is composed of two wrought-iron spans of 49.2 m, extended on the Commentry side by a stone access viaduct of about 31 m and a secondary wrought-iron span of 23.5 m on the Gannat side. The 98.4-m-long wrought-iron deck stands on a pier composed of four hollow cast iron columns that are 500 mm in diameter and 41.5 m high, and which stand on a stone block.

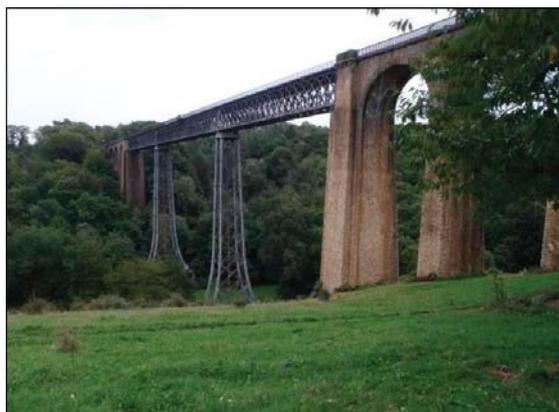
Figure 3. The Bellon Viaduct

The Bellon Viaduct consists of three spans of 40, 48 and 40 m, framed at its extremes by two stone access viaducts of 57.8 m on the Commeny side and 42 m on the Gannat side. The wrought-iron deck is 128 m long and rests on two piers, each composed of four hollow cast iron columns that are about 500 mm in diameter and stand on a stone block; the cast- and wrought-iron parts are 36 m high.

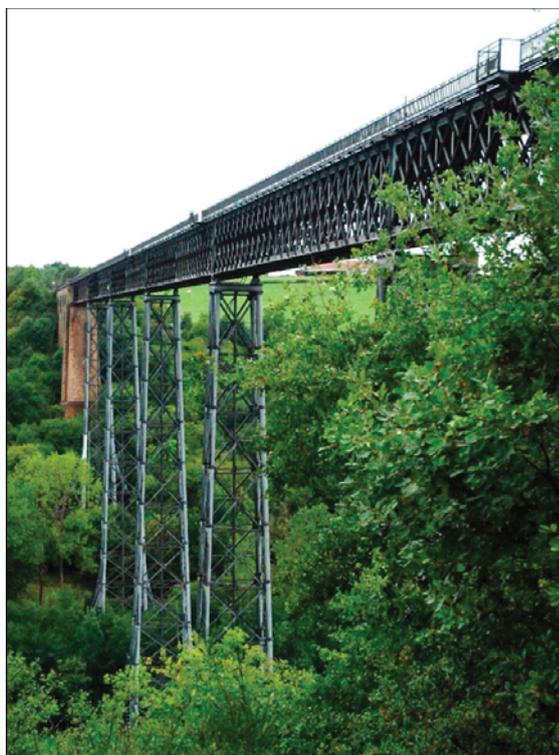
Figure 4. The Bouble Viaduct

The Bouble Viaduct is composed of six spans of 50 m surrounded by two stone access viaducts that are 71.3 m in length on the Commeny side and 23.7 m in length on the Gannat side. The 395-m-

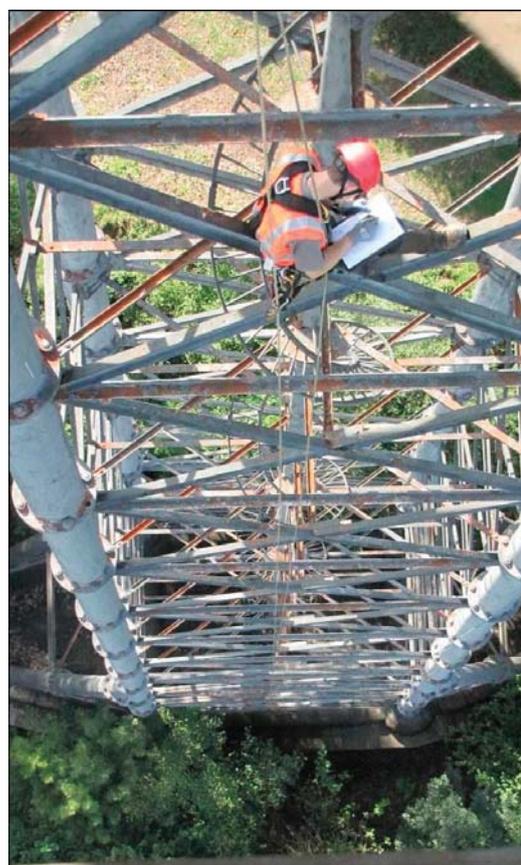
Figure 5. Visits by means of rope access works

- Brief visits were carried out with rope access works (Figure 5) and completed at night using hydraulic cradles (Figure 6) designed to provide up-to-date information on all the defects which may affect the structures (elements coming apart, splitting, possible cracking, etc.).

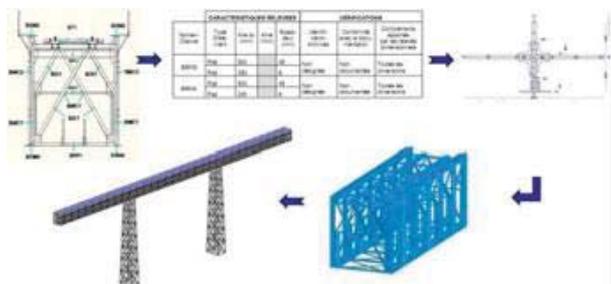
Figure 7. Structural analysis

The global FEM model of each bridge was created by SETEC TPI and Diadès using the Pythagore® software to check the structure of the bridges for cases of unusual loads. These prototypes were constructed using the results of the investigations, in particular the detailed dimensional measurements and the results of the samples taken to test the characteristics of the wrought iron. Even though the results of the tensile tests were heterogeneous, the yield and breakage limits of the samples were higher than those in the literature [1]. In order to ensure the accuracy and reliability of the results of the calculations that predicted the performance of these bridges, the models were based on the instrumentation and load tests carried out during the diagnosis phase (Figure 7).
