Site visit to check and ensure the safety of the overhangs

CARREL building

**Principal features:**  
Building in urban location  
Height of cornices: approximately 20 m.  
Architectural cornice with several facets.

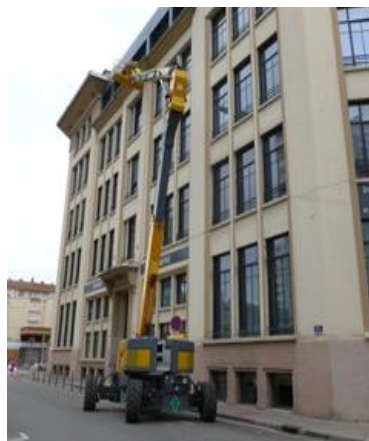
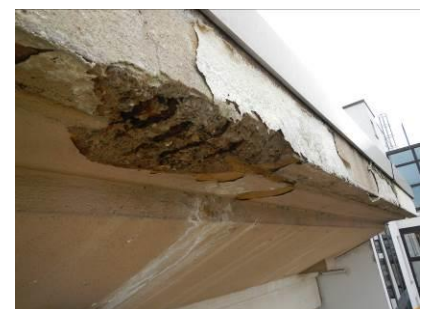
- A visual inspection and the auscultation with a hammer of all the cornices of the CARREL building,
- Locating the areas showing signs of defects (hollow sounds and assessment of their intensity, formation of flakes, fallen blocks, and so on) and establishing these on mapped surveys,
- Removal of unstable parts of the cornices that present a potential danger to persons in the footprint of the building.

Visit of inner courtyard by a team of rope access technicians  
Use of a type 3B 32-metre capacity boom lift to reach all the cornices.
