Studies into the restoration of the footbridge
Layout and repair pre-project

Pallon – Champcella footbridge

Recalculation, composite reinforcement of a footbridge, and layout of an abutment

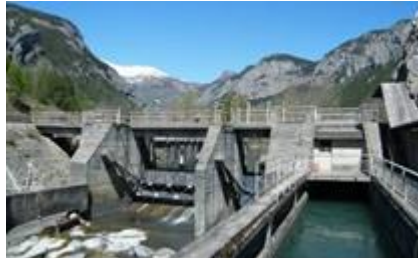
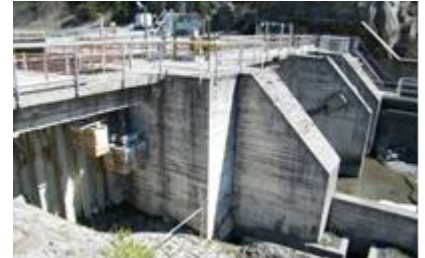
The structure is a T-shaped reinforced concrete footbridge with four spans. It rests on the barrage of Pallon (05) over an opening of approximately 30 m.

The water intake structure of Pallon leans against a scree slope on the right bank, and a limestone cliff on the left bank. It was built in 1960 as a replacement for the previous structure which presented defects due to pressure from the right bank.

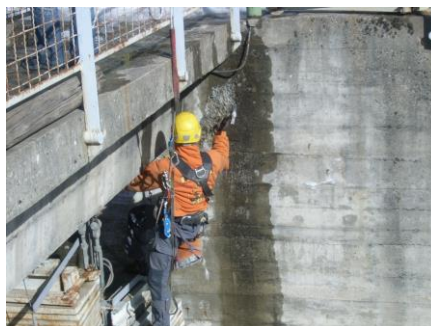
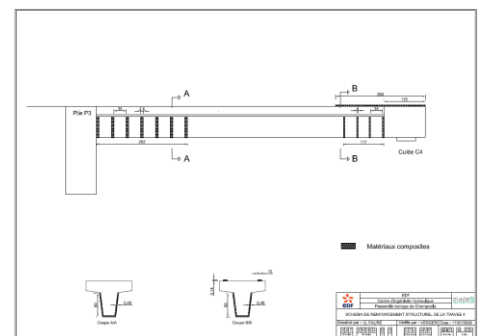
Recalculation, repair and reinforcement of a T-shaped footbridge which is subjected to floodgate load and counter-weight, and the layout of an abutment which butts against the footbridge due to pressure from the ground: predominant ground/structure interface on the behaviour of the footbridge.

- Pre-project layout of the abutment on the right bank to remedy and overcome the pressure from the scree on the right bank,
- Recalculation of the structure, with and without taking into account the pressure of the scree,
- Pre-project repair and everyday maintenance of the footbridge,
- Pre-project reinforcement of the footbridge, using composite materials composite.
